Stormwater Master Plan Town of Sandgate, Vermont

December 29, 2017

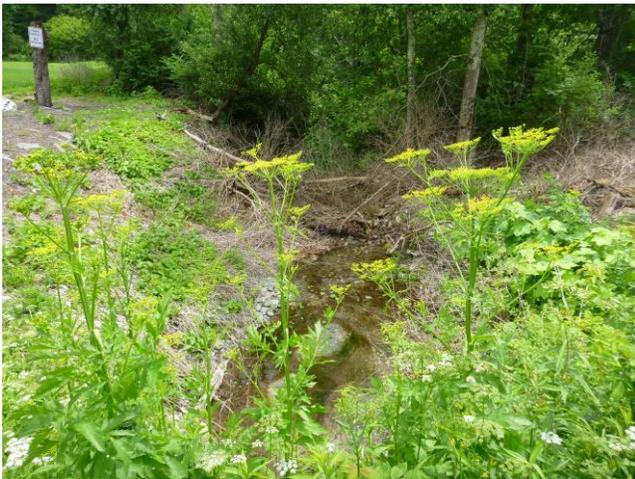
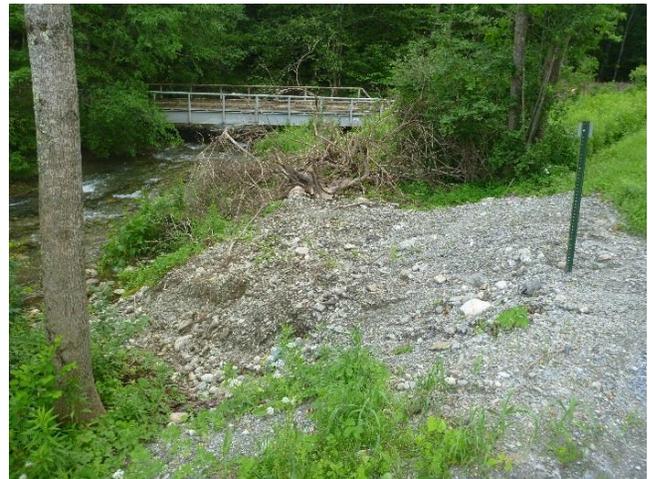
Figure 4: Ditch erosion at a culvert inlet along Woodcock Road (left) was one of the lowest scoring projects (DC-9). Large piles of loose sediment along Sandgate Road (right) following recent culvert and road work were the highest scoring project due partly to its proximity to the stream (DC-14).
